Report on  
Summary of Investigations

Proposed Residential Development  
Off Link Road, Wallsend

Prepared for  
Eden Estates (Newcastle) Pty Ltd

Project 91610.05  
December 2020

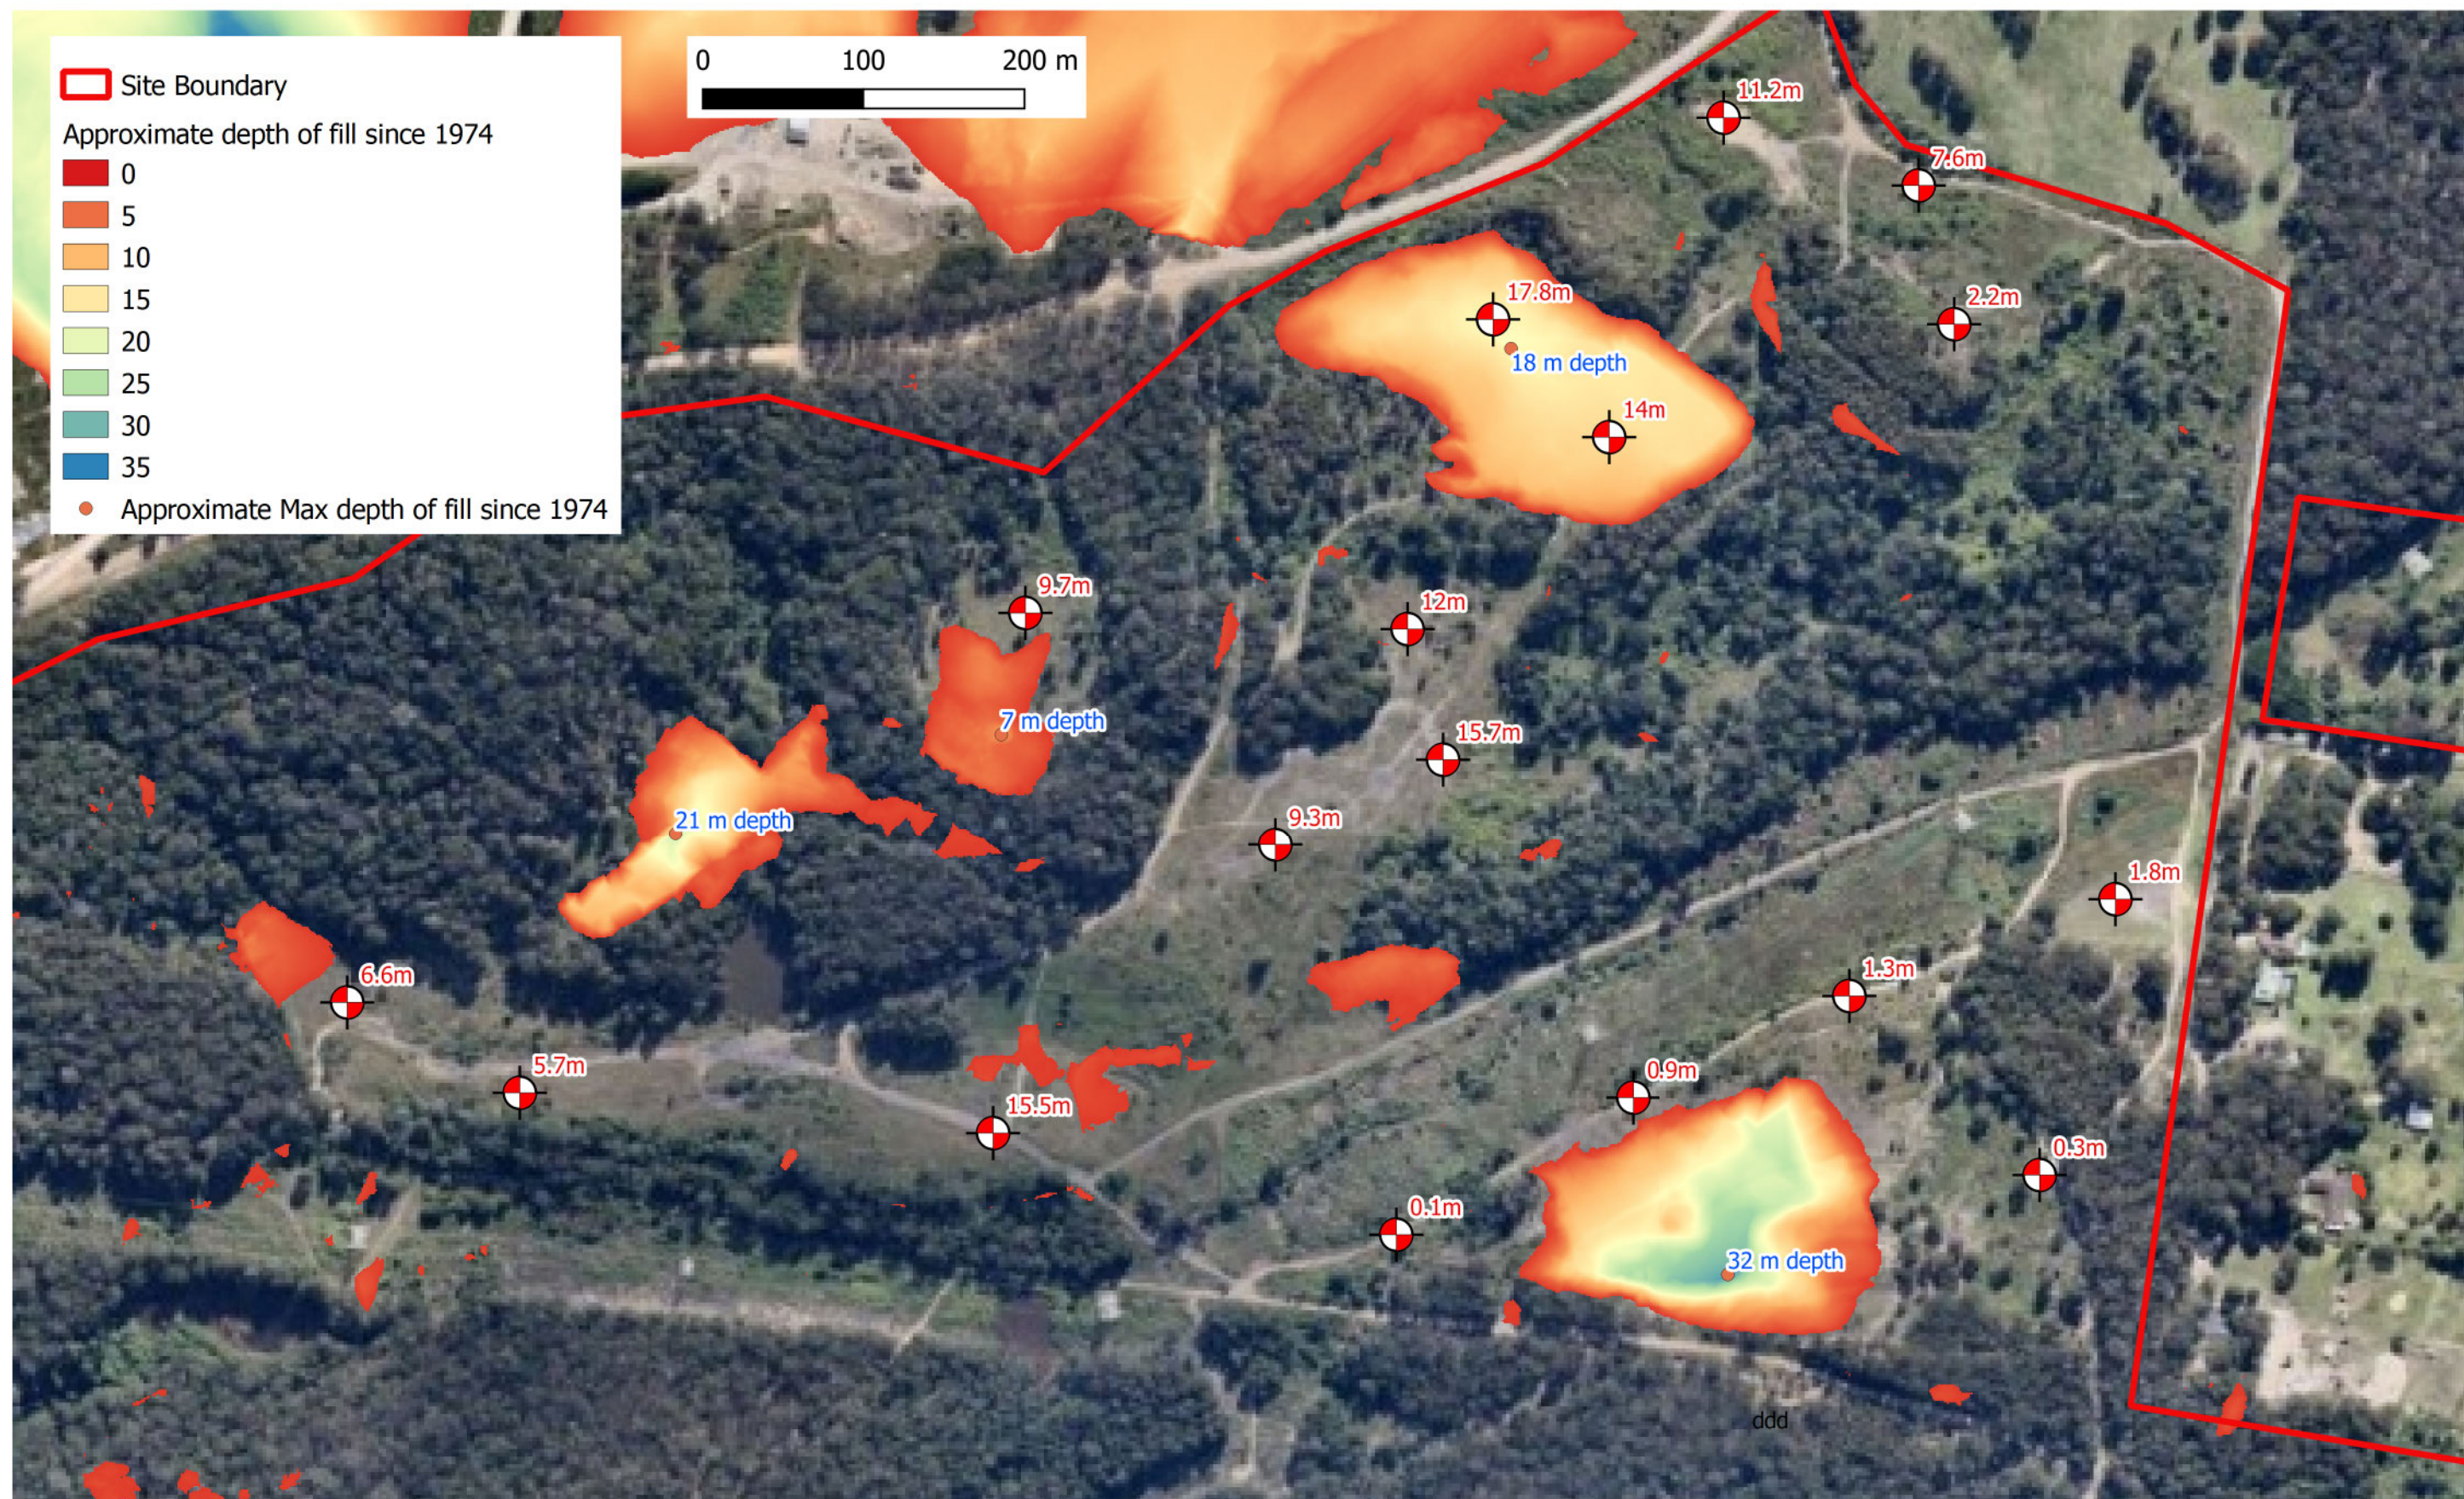
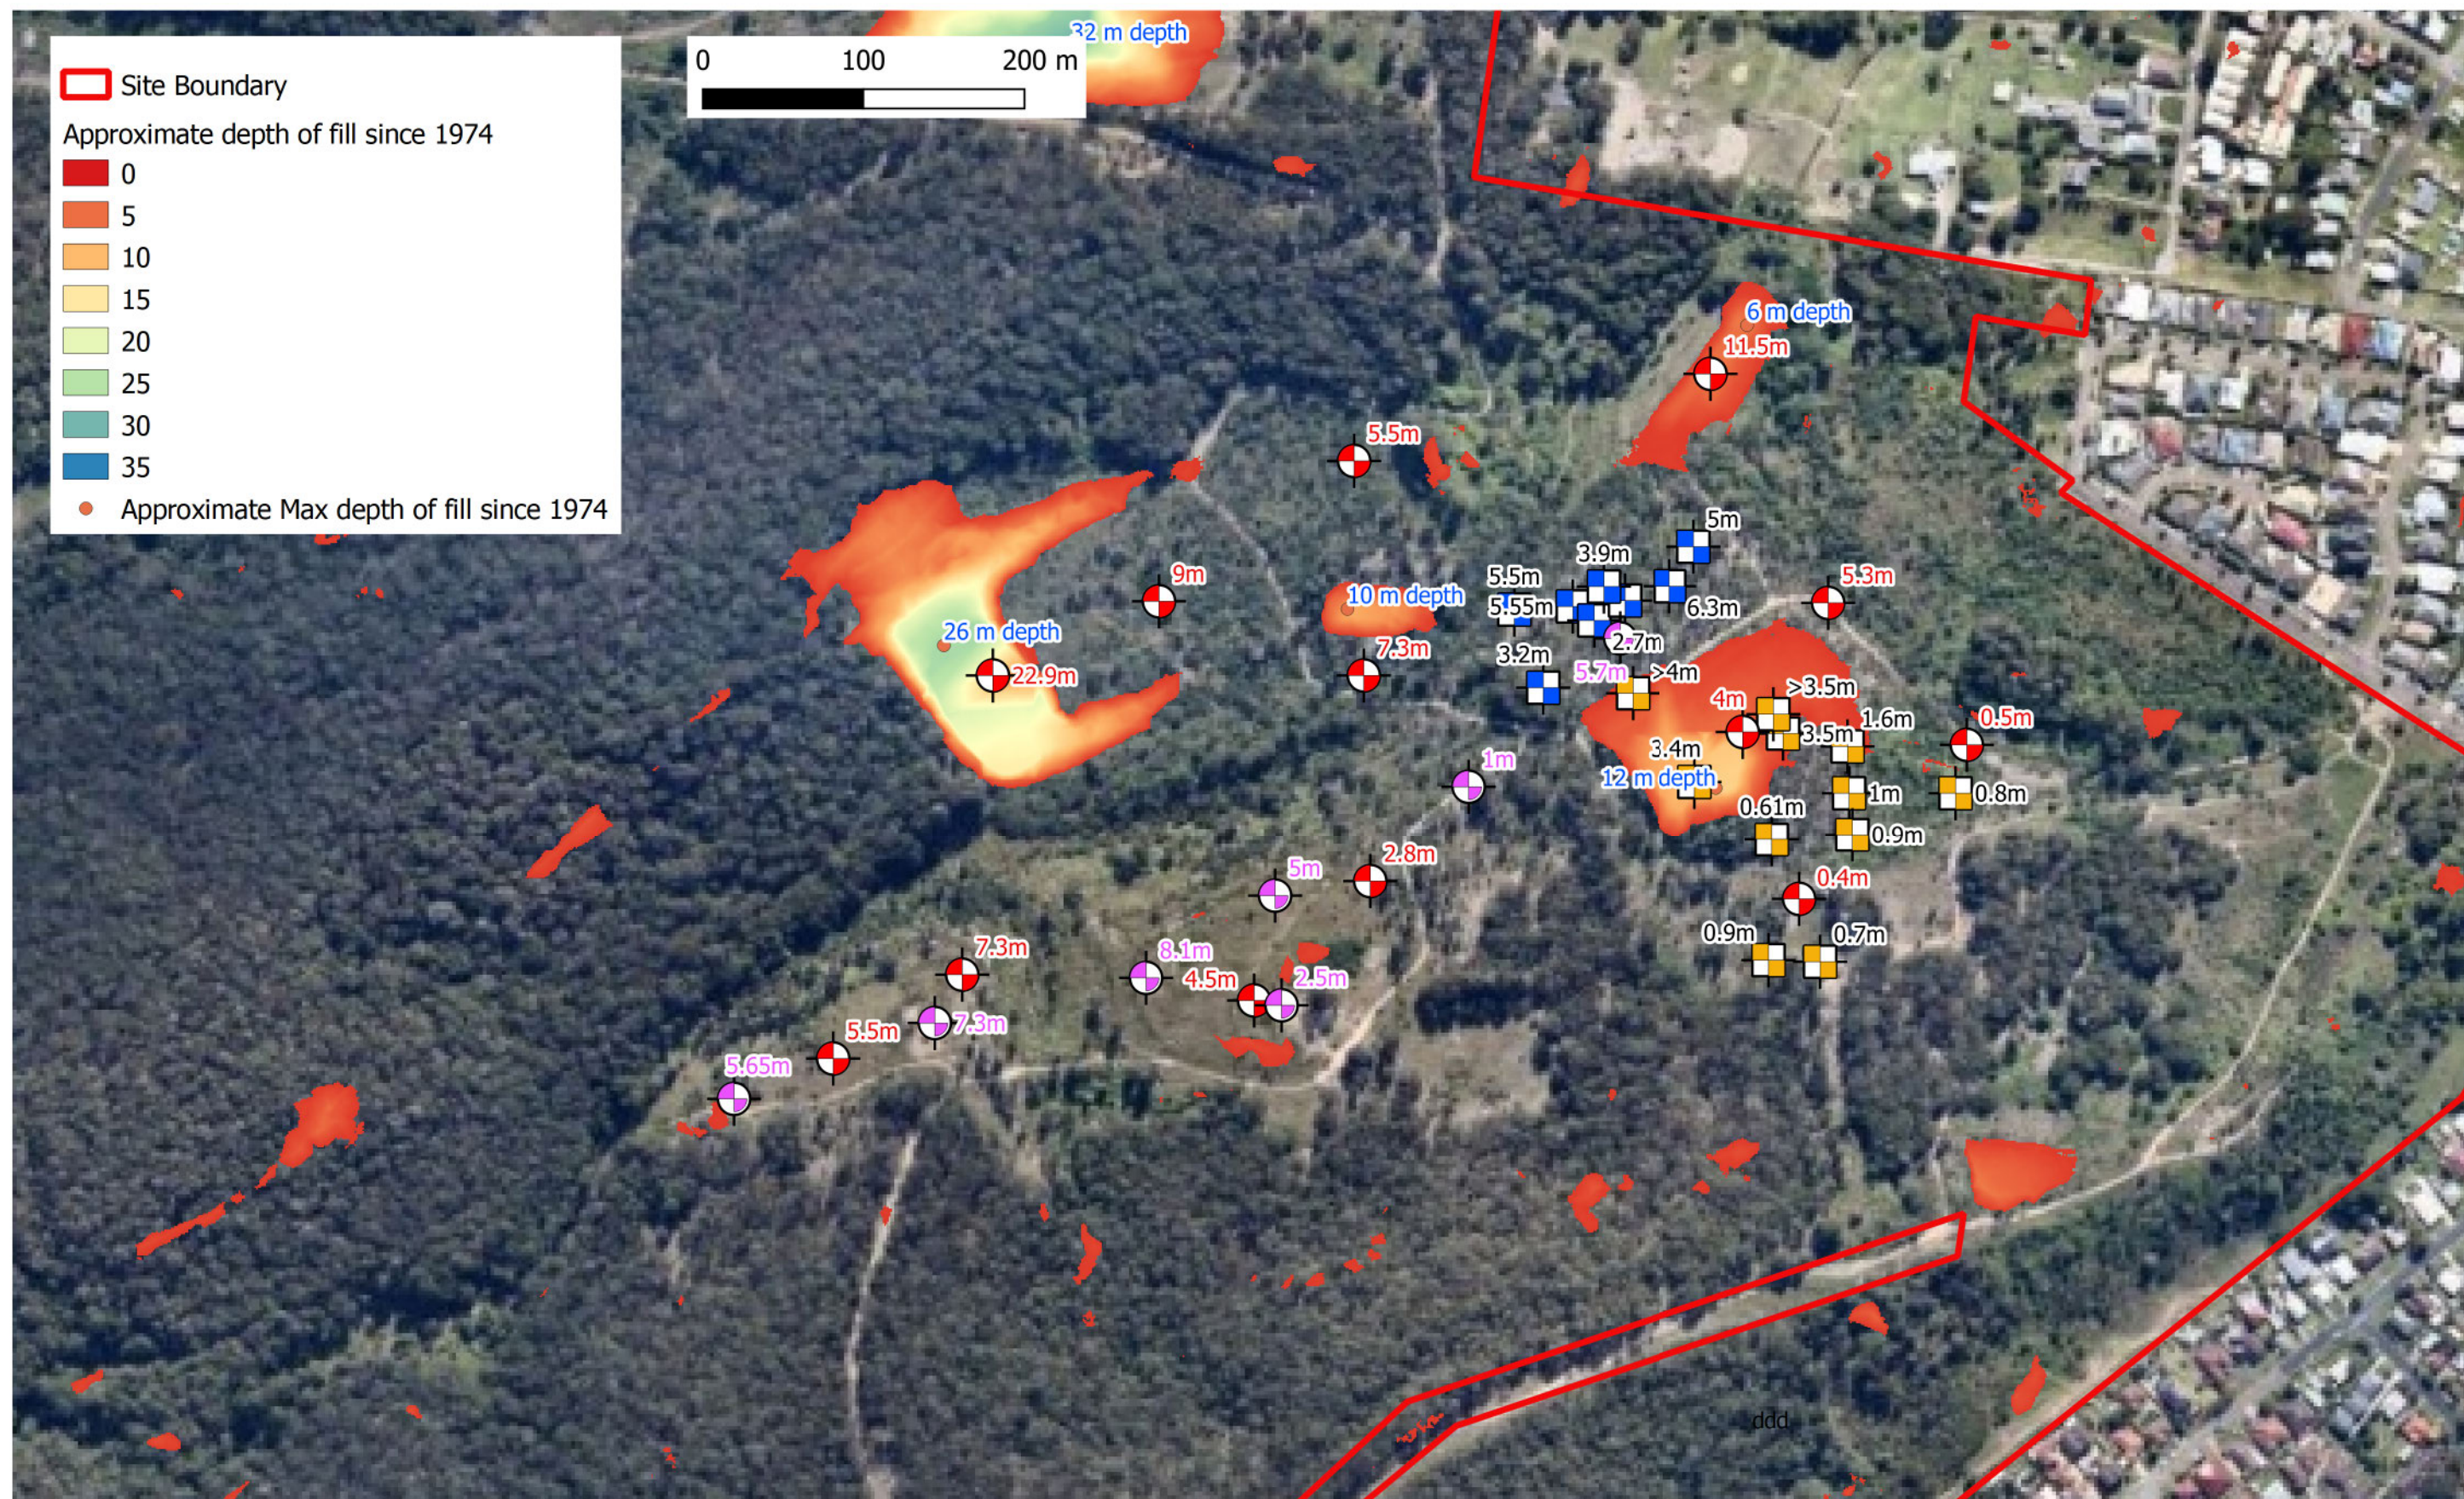
| | Page |
|---|---|
| Drawings 4-1 and 4-2 (DP, 2020c) – Fill Depth – Northern Part of Site | |

Drawing 4-1 and 4-2 in Appendix B provide both an indication on the depth of fill placed across the site since 1974 (shading), the approximate area of fill which appears to have been on the site prior to 1974 (green polygons) and the depth of fill encountered in test pits and bores undertaken by DP and others at the site. The ability of the existing fill to support future development is dependent on a number of factors, primarily relating to the degree of control used during placement of the fill, particularly in relation to the compaction achieved during placement. The results of the in-situ testing undertaken during DP (2020c), primarily comprising standard penetration testing (SPT), were utilised to provide guidance on the level of compaction (and relative density) of the fill material.

The results of the assessment indicate that the majority of the fill is in a poorly compacted condition and in areas contains shallow groundwater and is not suitable in its current condition to support future structures or surface development, and site improvement measures would be required to allow development within these areas of the site.

Based on the results of DP (2020c), coal rejects and coal fines have been placed within the site, to depths ranging from about 1 m to 28 m (refer Drawings 4-1 and 4-2 in Appendix B). The rejects area has a low risk of spontaneous combustion. There is, however, a potential for combustion from external sources (such as bushfires). The risk profile for combustion is dependent on the possible external ignition source and mechanisms. It is considered that the risk of combustion could be managed by a combination of blending the existing fill with non-carbonaceous material, recompaction of the existing fill and/or blended material, and / or provision of a suitable cap of non-combustible material over filled areas.

These improvement measures would also be tailored to mitigate additional identified risks, such as potential for combustion of carbonaceous material and generation of acid, and is likely to include removal of the existing fill and recompaction after blending with non-carbonaceous material.

It may be possible to undertake a less onerous earthworks procedure, such as partial removal and re-compaction of the upper portion of the existing fill together with the provision of a suitable capping layer, followed by support of future structures via piled foundations through the existing fill profile to be founded within the underlying rock profile. This alternative site preparation option as the approach to earthworks will depend on the type and scale of development; relatively rigid multi-storey buildings, for example, would probably require piles but flexible warehouse-type buildings may be suitable to be supported on re-compacted fill with some structural allowances to accommodate settlement.

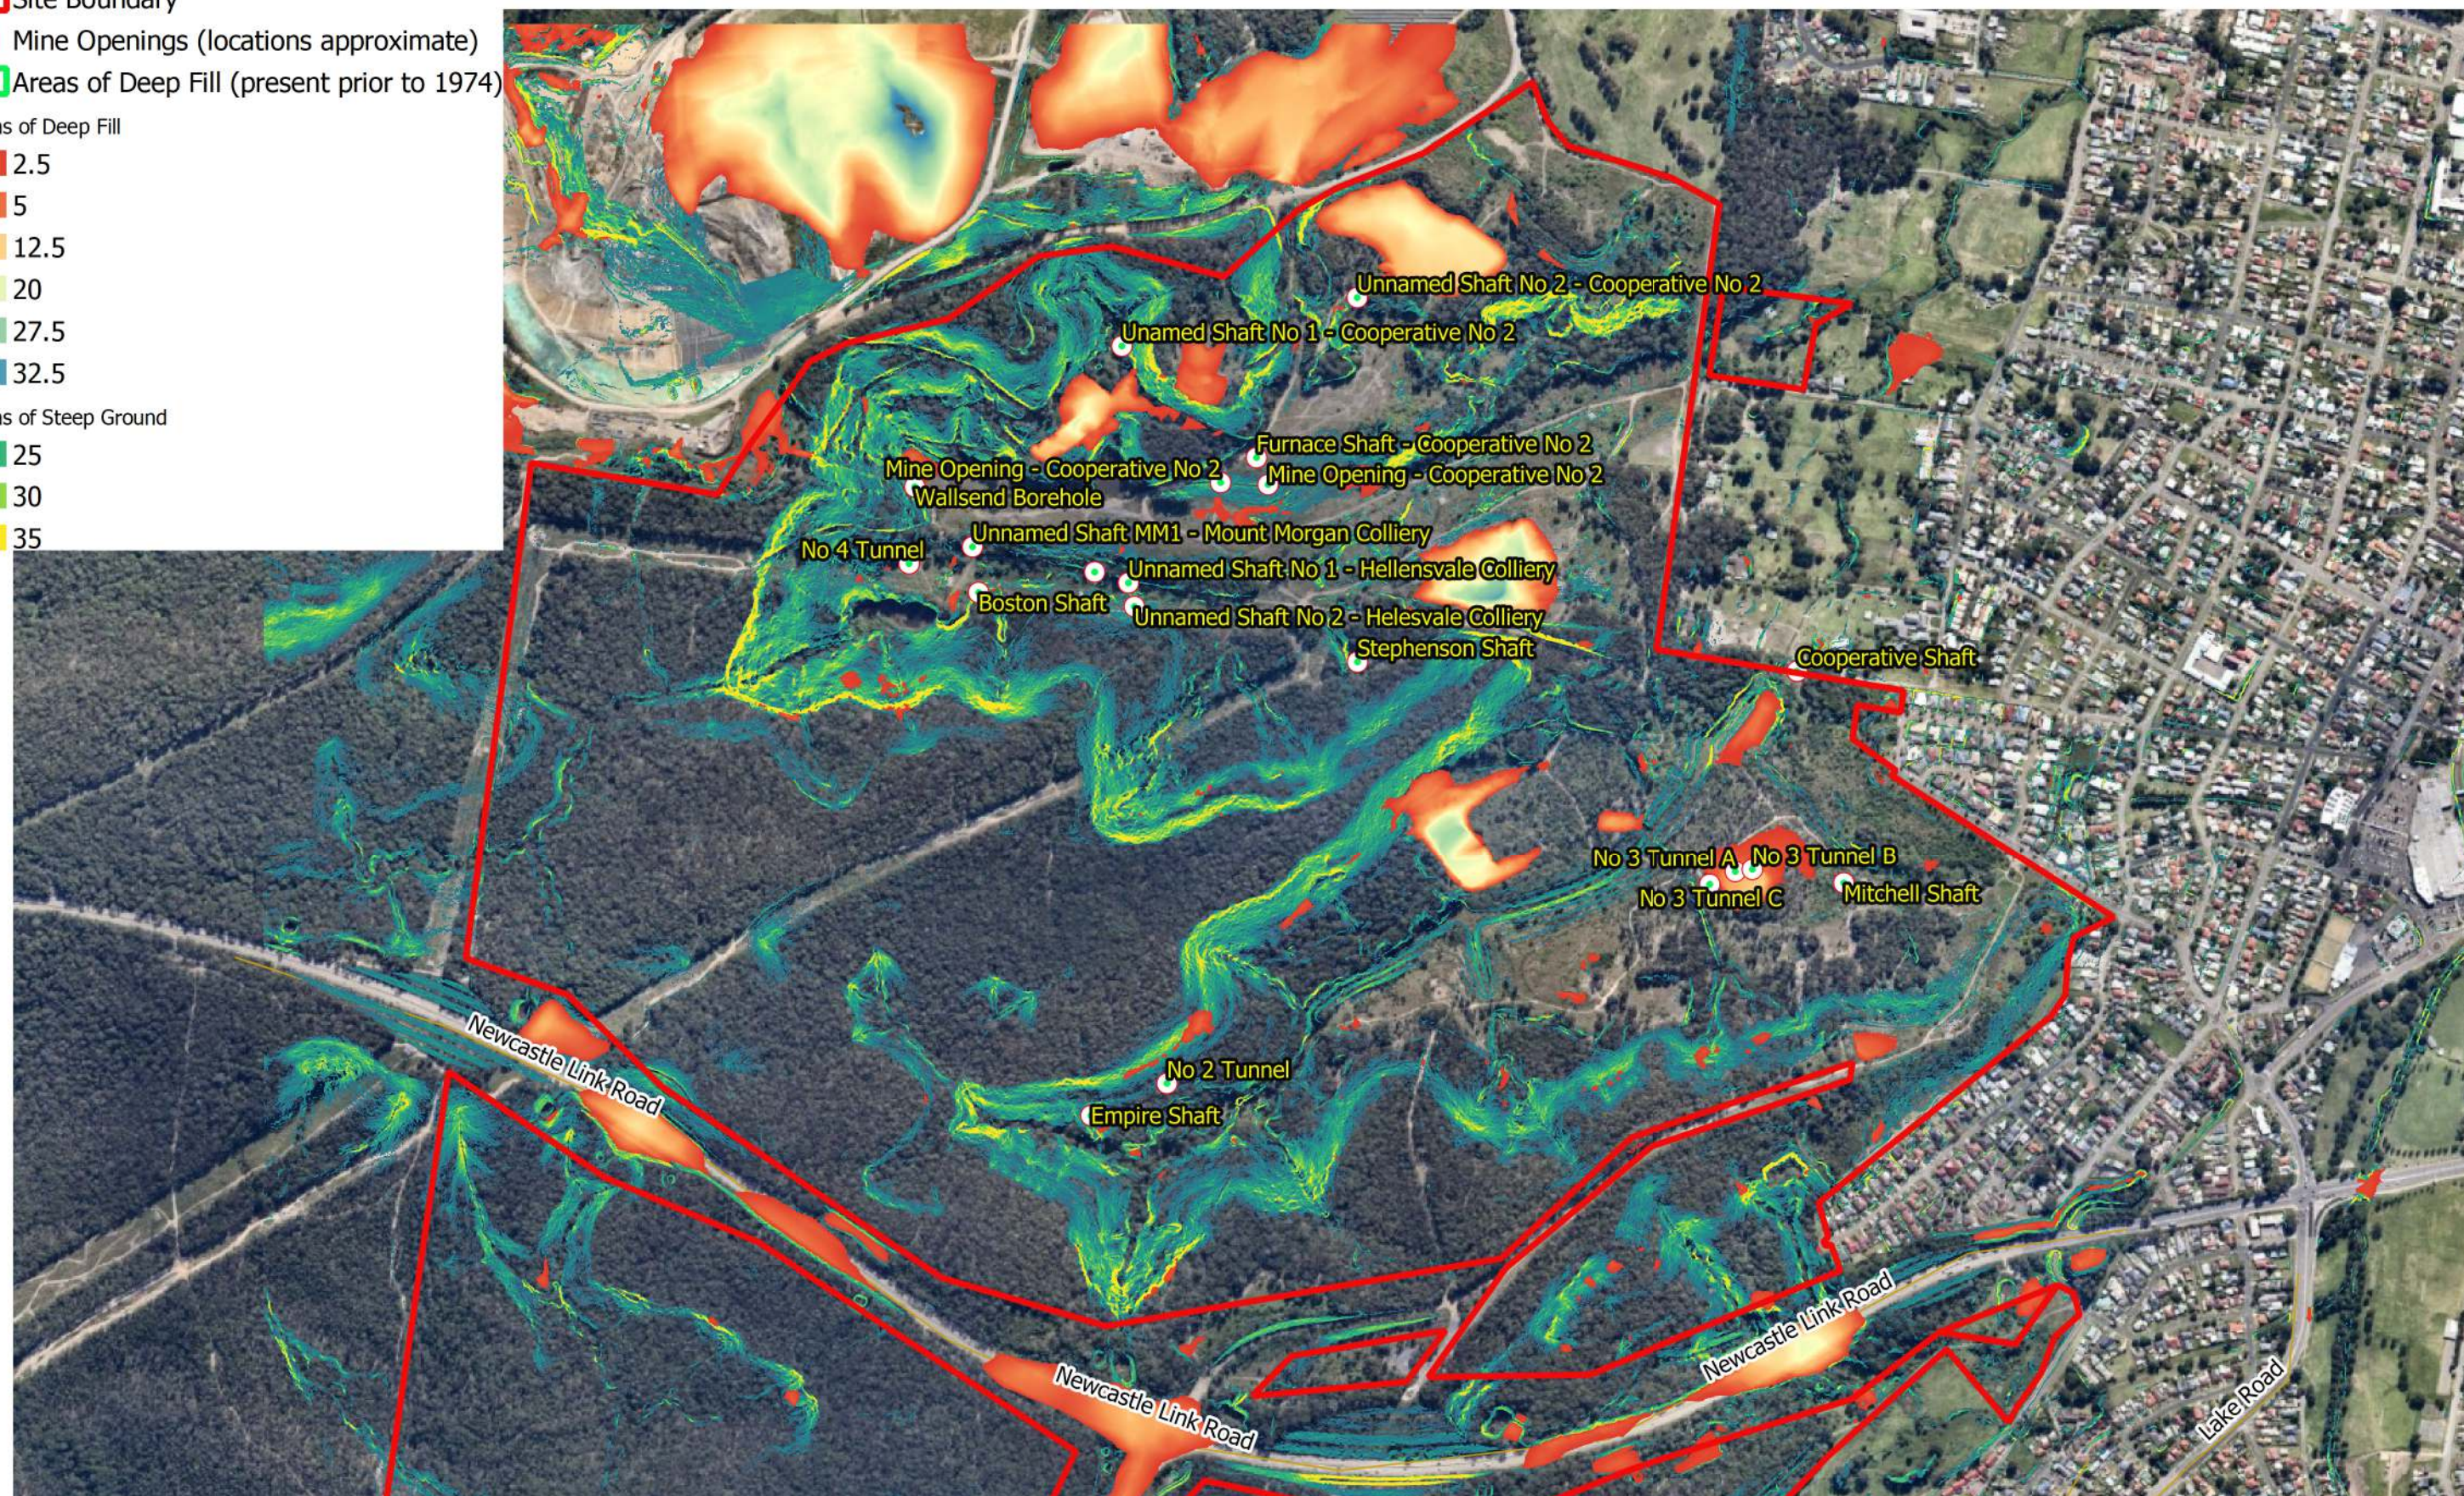
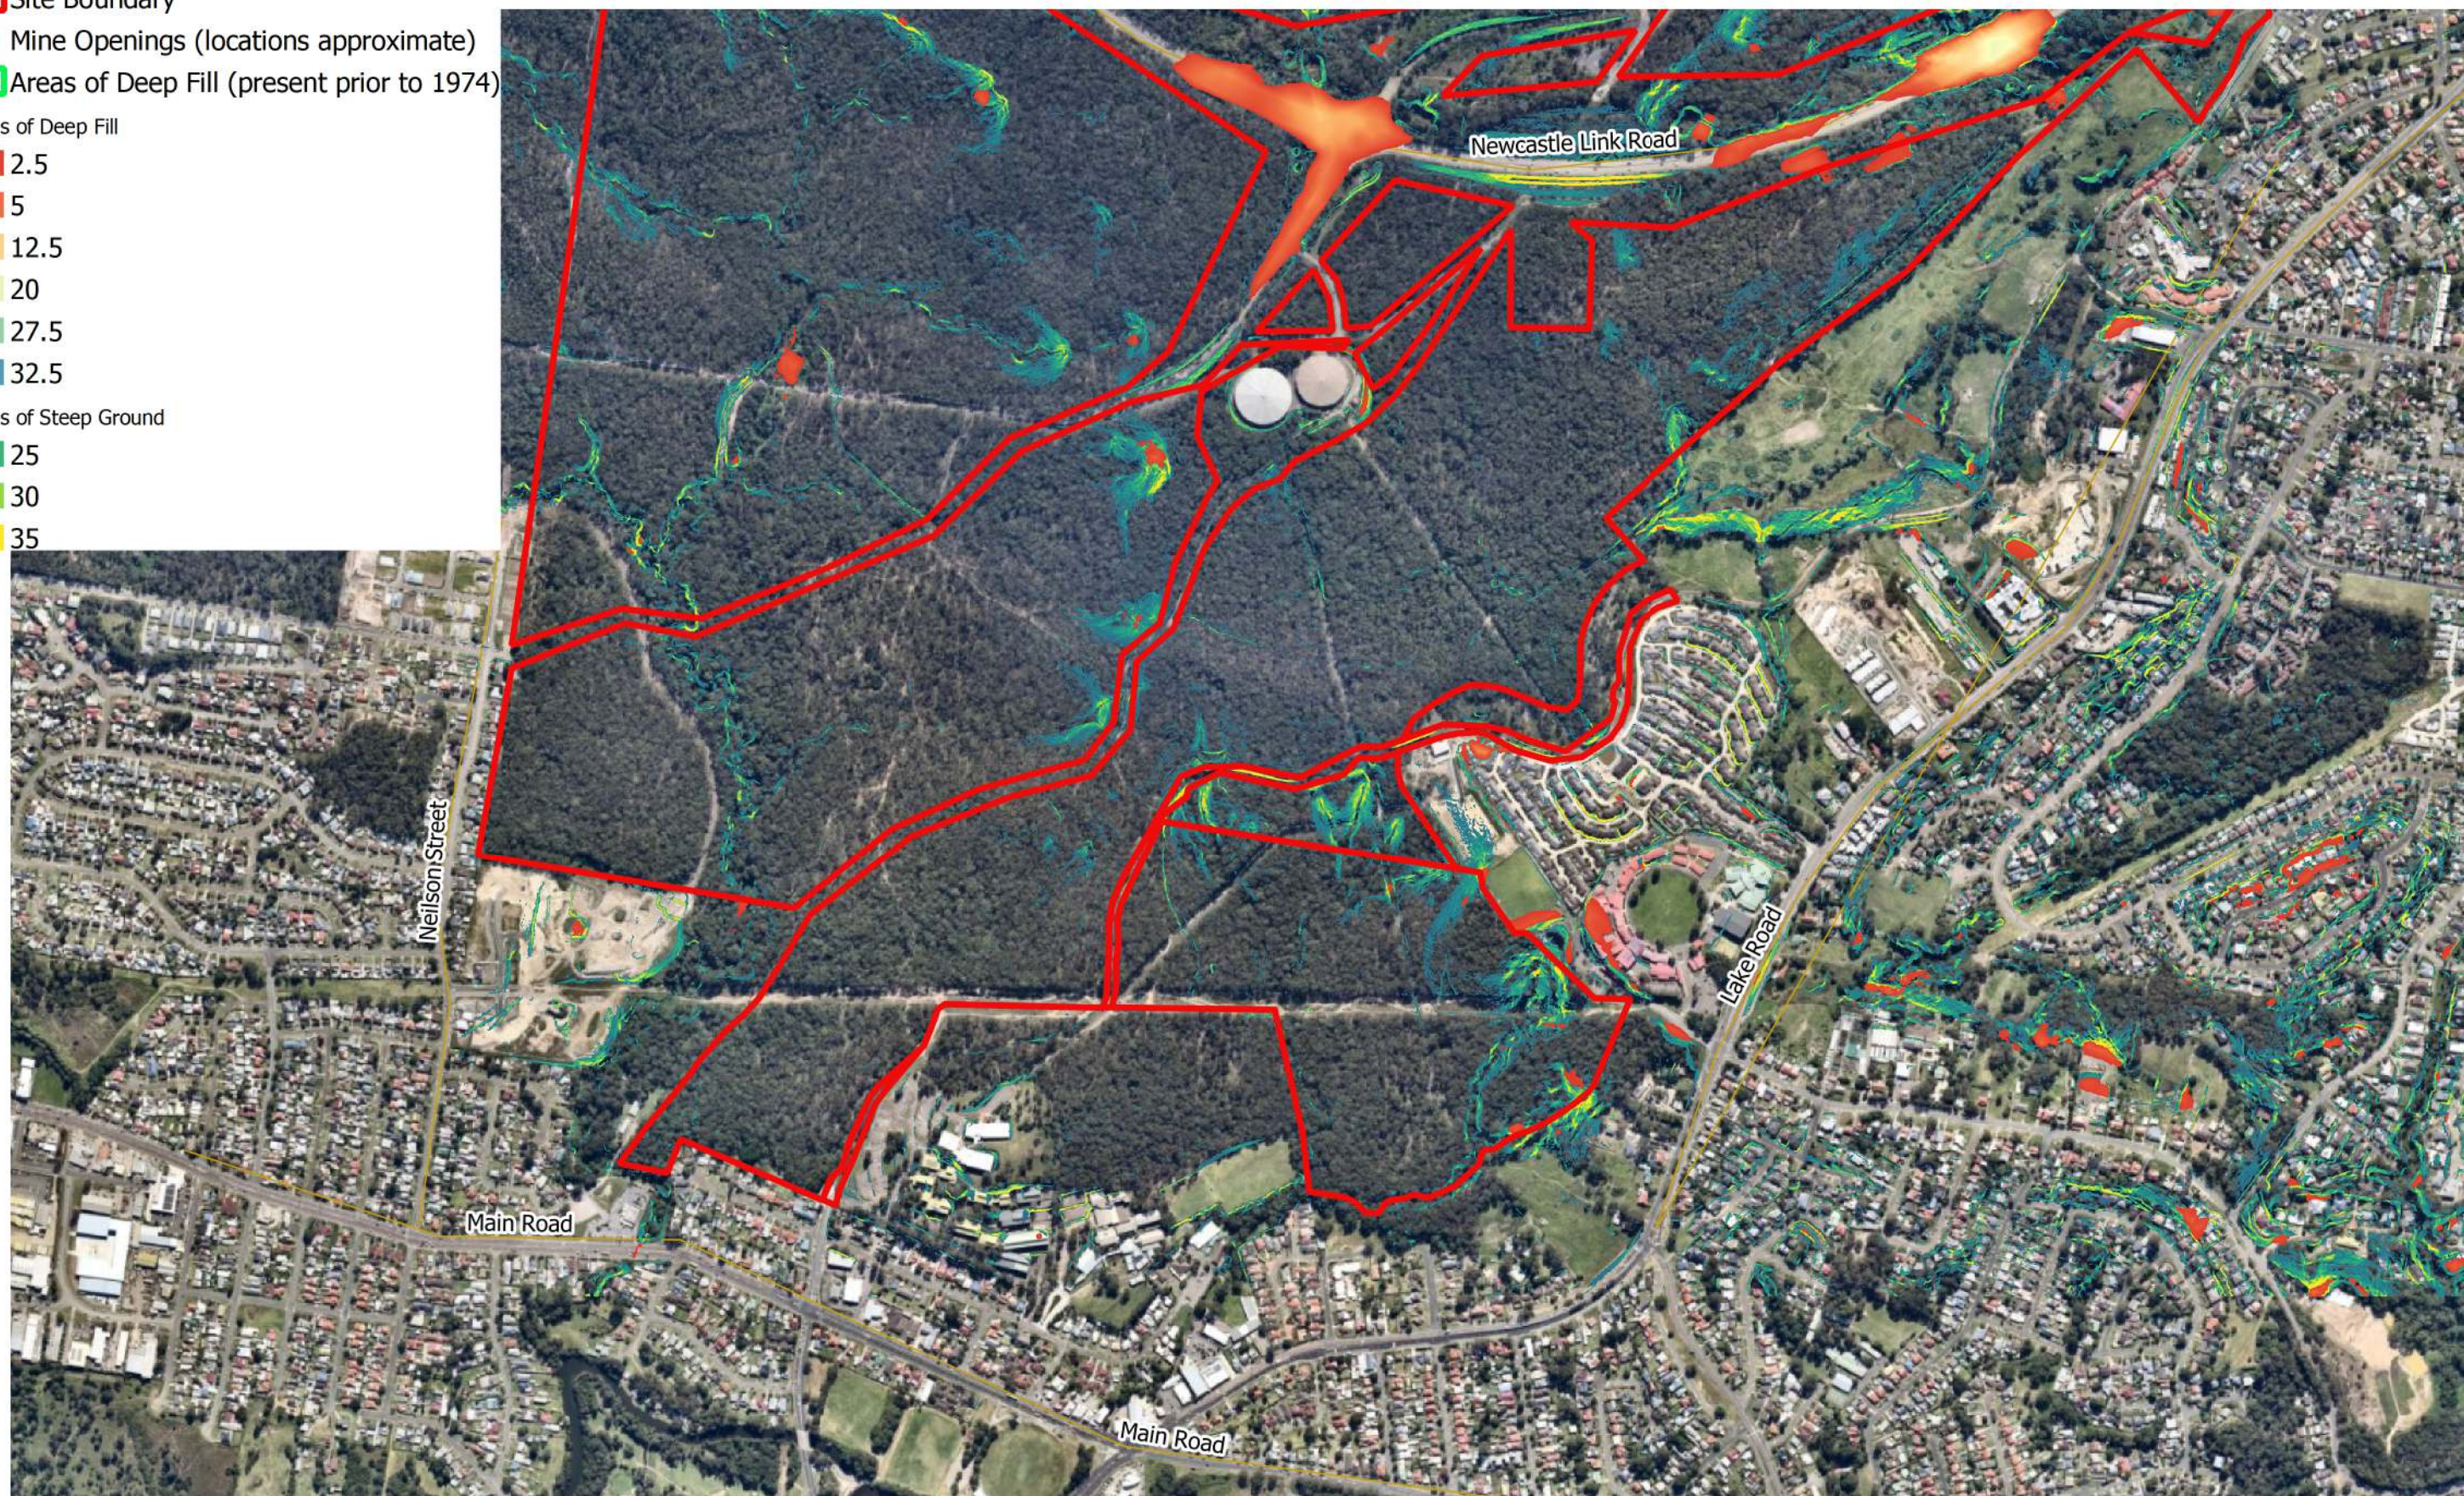
Drawings 8-1 and 8-2 (DP, 2020b) – Identified Areas of Geotechnical Constraints

Drawings 8-1 and 8-2, in Appendix B, provide an indication of where the principal hazards have been identified on the site (noting reference should be made to Drawings 4-1 and 4-2 for areas of fill which appears to have been placed on the site prior to 1974), and are briefly discussed in Sections 4.2 to 4.12 below. A summary of the assessed risk level and approximate area of the site affected by the hazard is provided in the section titles.

Drawing 8-1 to 8-2 in Appendix B shows the areas of the site with slopes of greater than 15°.

The trial box cut experienced a high wall failure and exposed an ancient landslide of up to 12 m in height overlying the Nobby's Tuff. Some tension cracking was observed in the steep ground upslope of the former trial box cut during the 2020 inspection by DP.

The approximate location of these shaft and mine openings are shown on Drawing 8-1 and 8-2 of (DP, 2020a). Further investigation will be required, including subsurface investigation to locate key shafts within these record traces to allow more accurate georeferencing and positioning of mine openings.

Note that additional mine openings and shafts may be present on the site - additional work may be required to identify location and condition of openings

Confirmation of the sealing of these mine openings would be required together with their exact location where not known.
